Back to the Light: The Mysterious Sinking of *UC-71*

By Florian Huber, Ph.D.

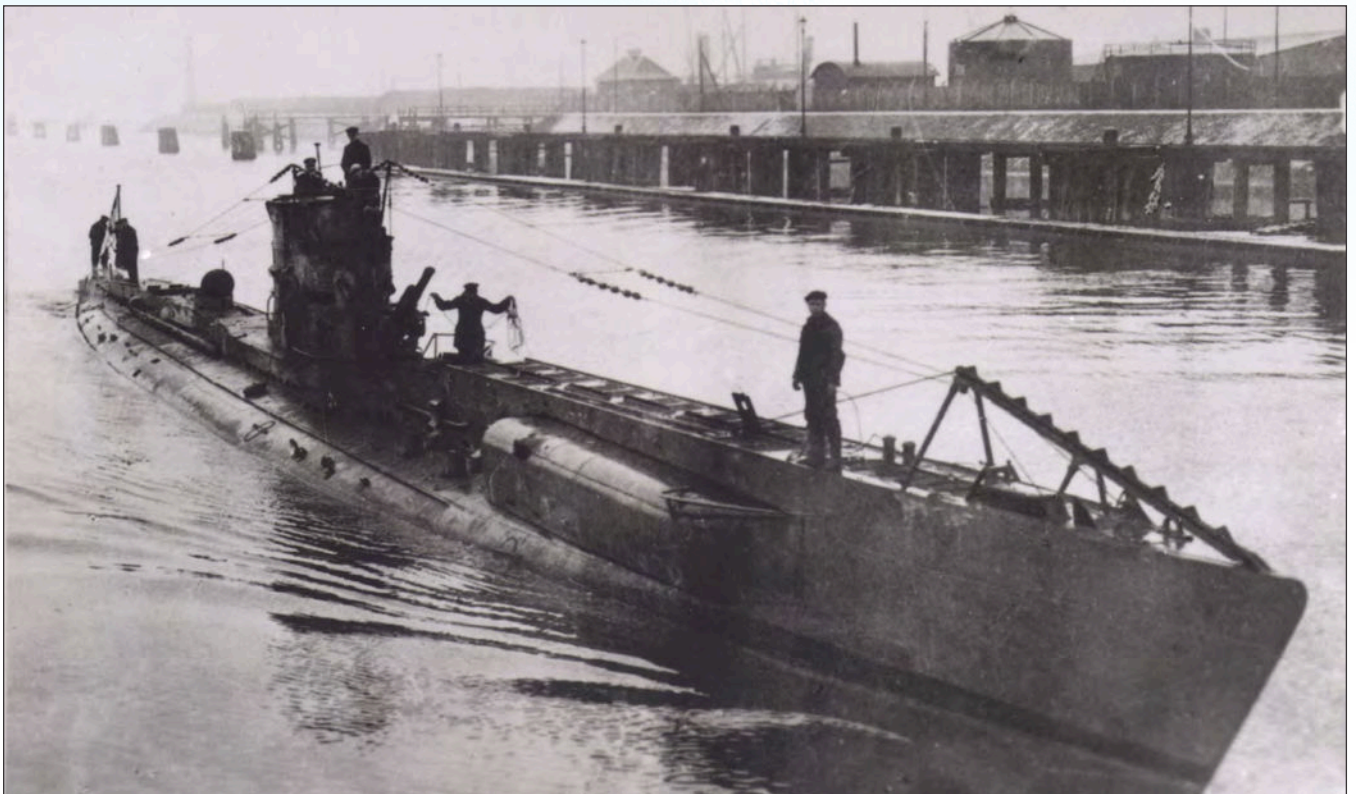
*UC-71: the 53m-long U-boat had a crew of 26 and could dive to 50 meters.
(Courtesy of Bibliothek für Zeitgeschichte Stuttgart)*

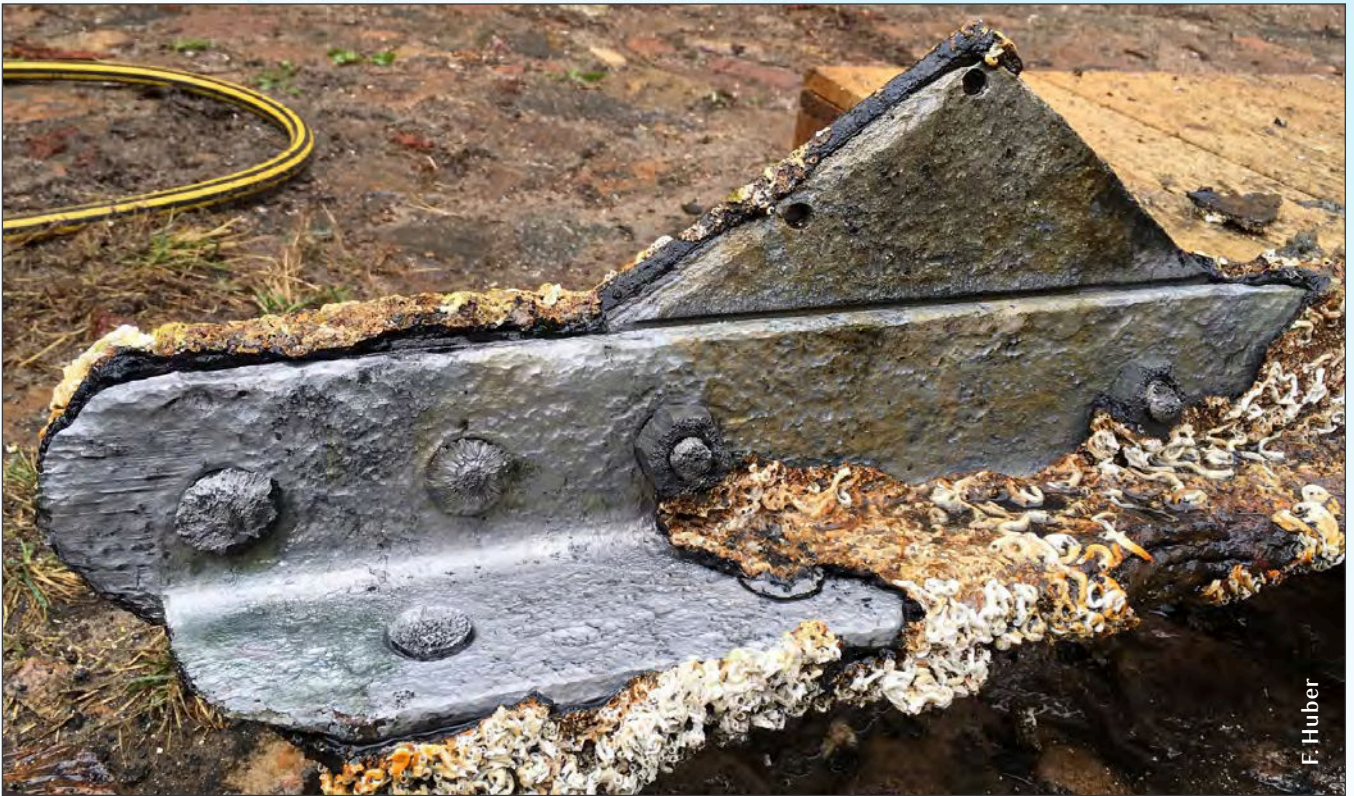
The net cutter is astonishingly well preserved. After the initial, rough clean, the original grey coat of paint began to show through the layer of corrosion.

Net cutters were designed to cut submarine nets, which hung like curtains in the Strait of Dover as well as in all the English river mouths and port entrances. These nets often included mines which were directed or driven away from the U-boat by two steel cables attached to the end of a saw running in parallel from the bow over the tower to the end of the stern. Sometimes the net cutter would be supported by a second, directly-welded saw tooth below the bow.

The *UC-71*'s 4.1m-long and almost 200-kg net cutter was recovered in the summer of 2016 using lift bags and an electric winch; it was then transported to the State Museum at Schloss Gottorf in Schleswig, Germany. At the central archaeological workshop there, the net cutter was laid in a basin with demineralized water, where it will be desalinated

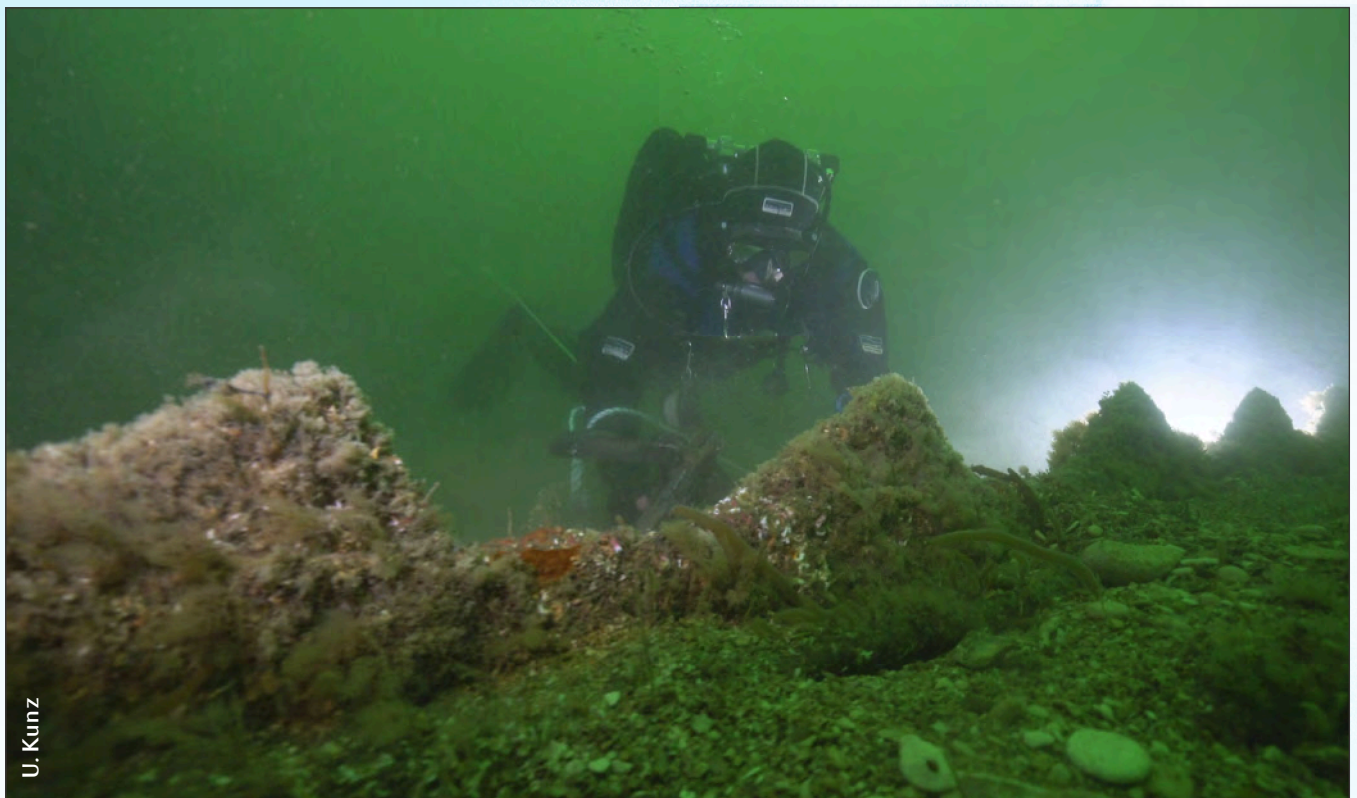
The net cutter lay roughly five meters from the bow area; it was likely torn off during scuttling.
