Underwater Archaeological Investigations of First World War Shipwrecks around the Island of Heligoland in the German North Sea

Florian Huber

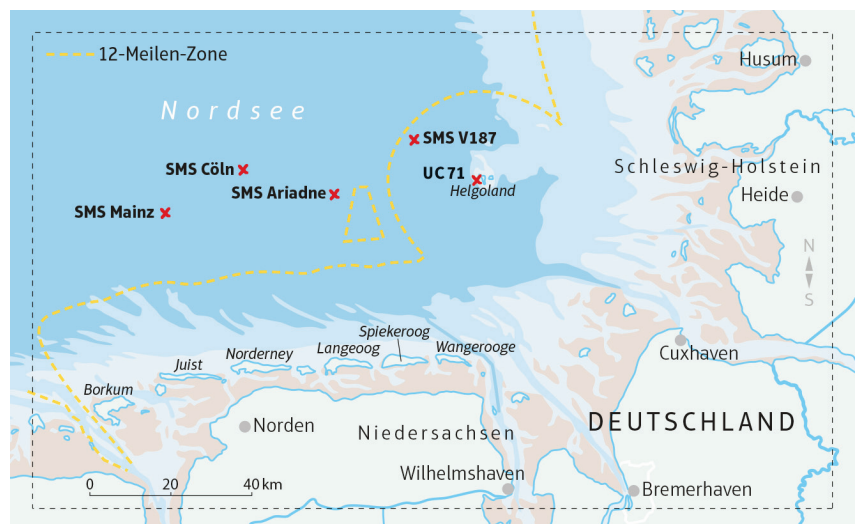
Fig. 2: Wreckage sites of the five German warships. The battle on August 28th 1914 spread across an area of 4.500 square miles within the German Bight (Jana Ulrich)

Second World War. Due to its long settlement history and military importance, numerous shipwrecks from different periods can be found in the waters around the island (Fig. 2).³

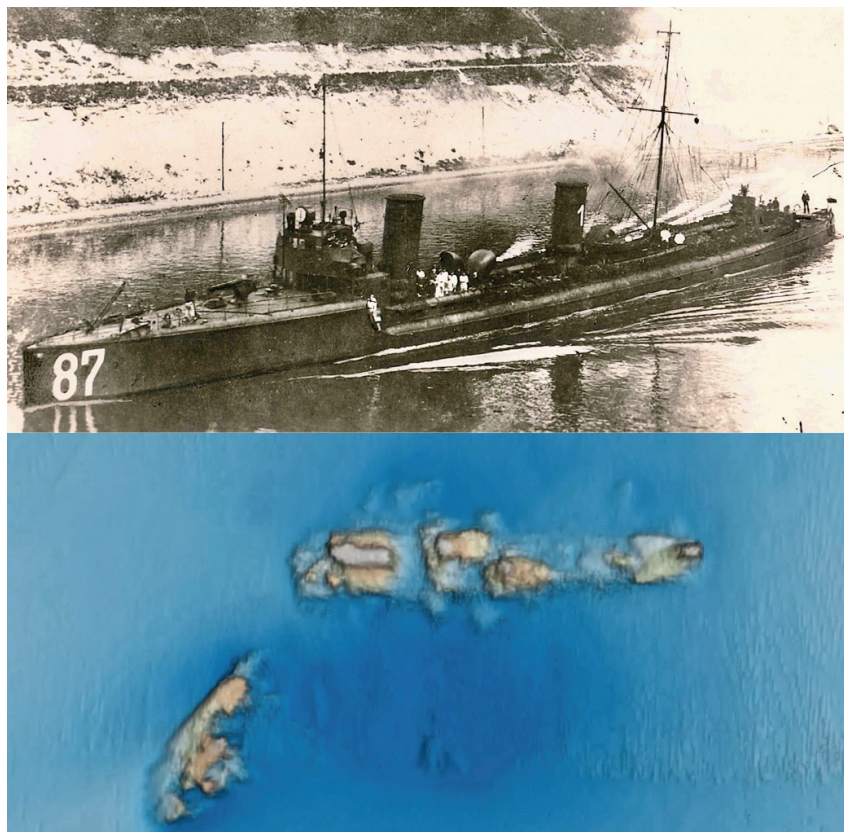
Fig. 3: Torpedo boat V 187, historical photograph and multibeam-image of the present-day site (Collection German Naval Association / Sea War Museum Jutland)

V 187, in service since 1911, was damaged and lost in the early hours of August 28 at around 10:10 am by British destroyers HMS NOTTINGHAM and LOWESTOFT, both equipped with superior firepower (Fig. 3).⁹ As this shipwreck had not yet been identified at the time of the diving operation, a porcelain bowl and a signal flare cartridge

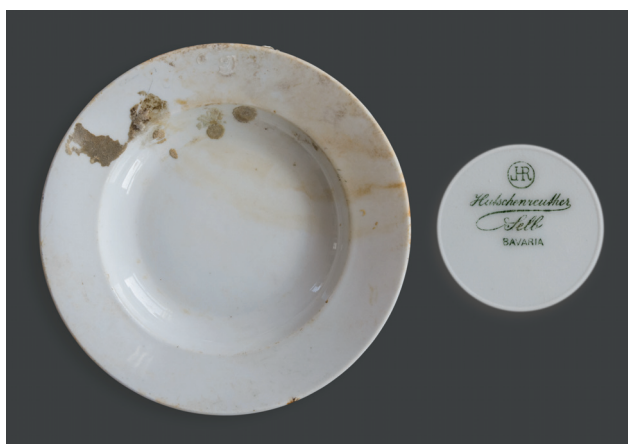
Fig. 4: Torpedo boat V 187, porcelain plate recovered from the ship's mess, with the hallmark of the manufacturer Hutschenreuther in Selb, Upper Franconia (F. Huber)

were recovered for further investigation. The bowl bore the hallmark of the German porcelain manufacturer Hutschenreuther from Selb in Upper Franconia. This narrows the date down to 1887 to 1920, corresponding with the sinking date of V 187 (Fig. 4).¹⁰ The flare cartridge was a brass calibre 4 (colour red) with a circular grooved base, exactly the type used by the German Imperial Marine.¹¹ The examination of the recovered and in situ artefacts, combined with the vague coordinates of the ship's sinking, the dimensions and construction of the shipwreck as well as a torpedo, confidently allow for identification as the lost torpedo boat V 187.¹²

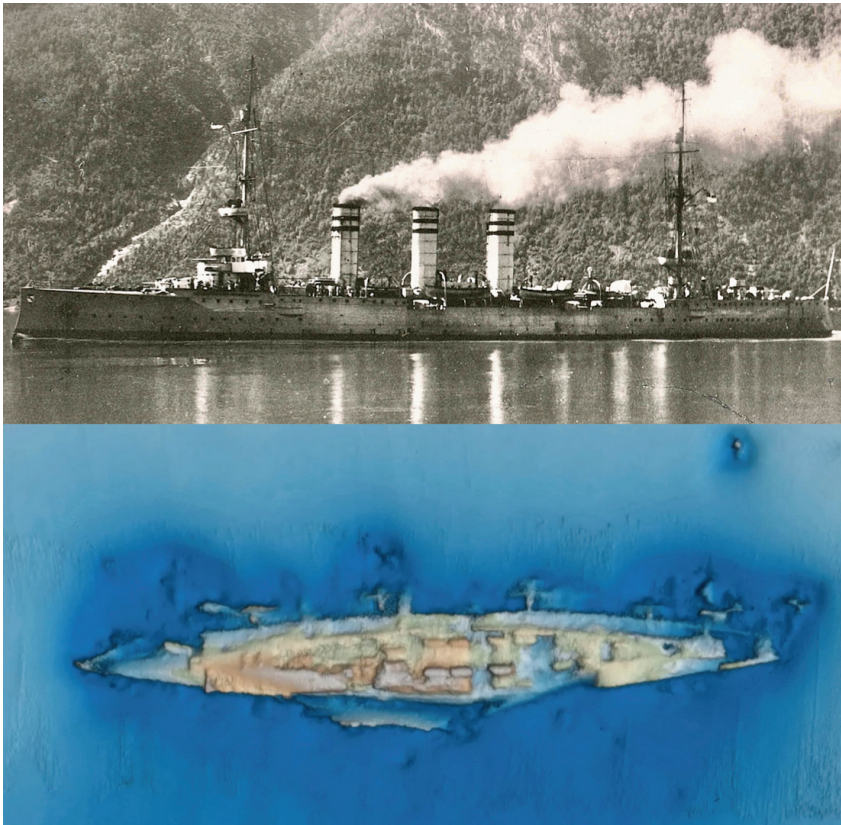
Fig. 6: SMS MAINZ, historical photo and multibeam-image of the present-day site (Collection German Naval Association / Sea War Museum Jutland)

SMS MAINZ, 130 m long and 14 m wide, like SMS CÖLN, was a small cruiser of the Kolberg class, a series constructed by the AG Vulcan in Stettin and the successor of the Dresden class.¹³ It was first commissioned in 1909. The Kolberg class was the first series of ships equipped with a turbine engine. On the morning of the 28th of August at around 10:00, SMS MAINZ left the estuary of river Ems towards Heligoland, where, at noon, it encountered several British destroyers and opened fire (Fig. 5). During the ensuing battle, numerous grenades and a torpedo struck the SMS MAINZ, causing irreparable damage. The commander ordered the ship to be scuttled, to avoid the warship being seized by the British (Fig. 6). The crew opened the flood valves resulting in the vessel's sinking 40 minutes later, at 14:10.

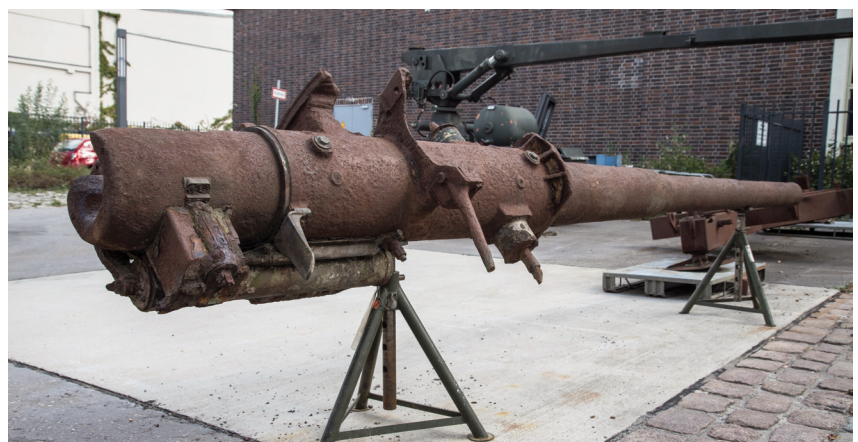
Fig. 7: A gun from SMS MAINZ that was illegally salvaged by Dutch divers. Today it belongs to the Military History Museum of the German Armed Forces (Militärhistorisches Museum der Bundeswehr) in Dresden and has been restored.

seized and handed over to the Military Museum in Dresden (Fig. 7).¹⁴

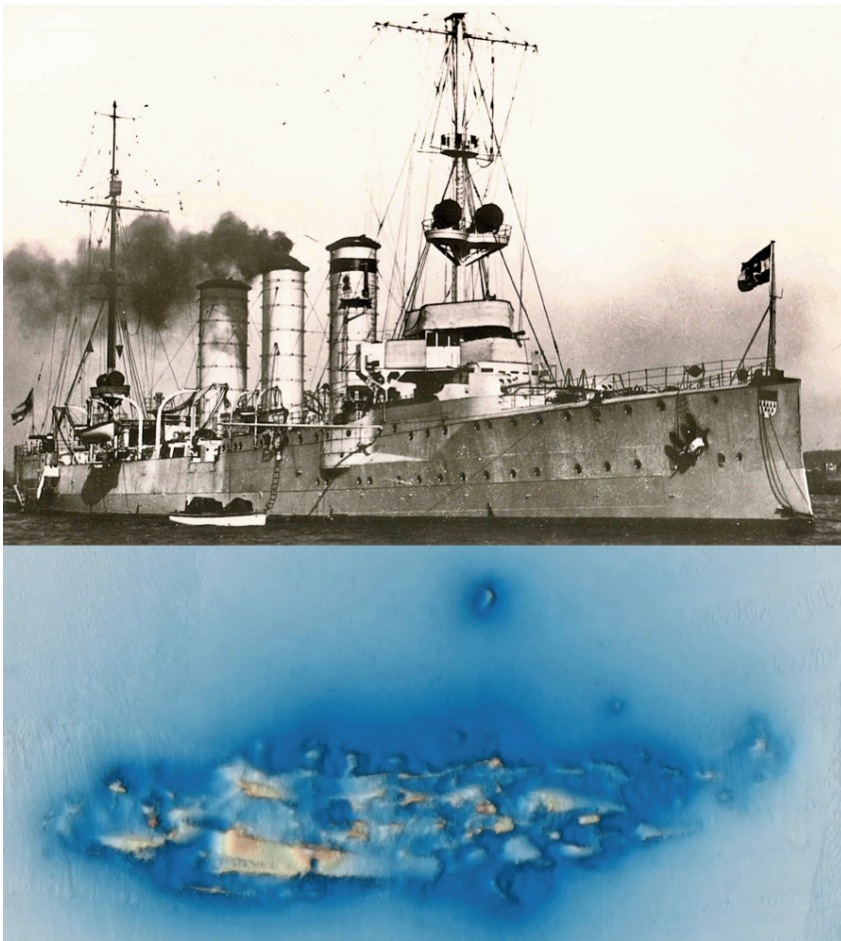
Fig. 8: SMS CöLN, historical photo and multibeam-image of the present-day site (Collection German Naval Association / Sea War Museum Jutland)

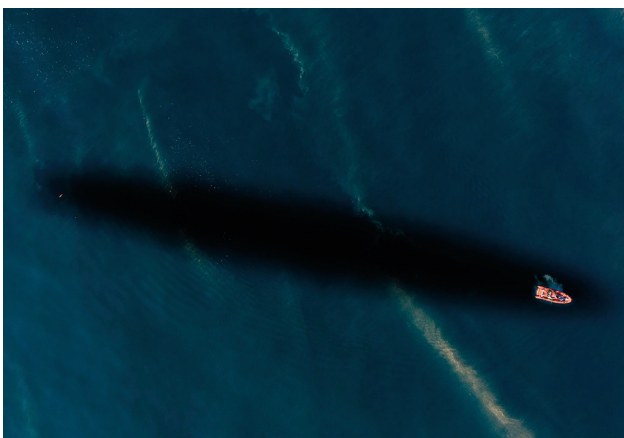
The wreck of the SMS CöLN lies at a depth of approximately 40 m (Fig. 10). It was discovered by coincidence in 1979 and demolished by detonation shortly after, to clear the modern shipping route. Thus, it is severely damaged and almost unrecognisable as a ship. Only a few construction elements can be safely identified (Fig. 11) and some artefacts, that were probably recovered before the demolition are displayed in the Museum “Windstärke 10” in Cuxhaven.¹⁷

Fig. 10: Size comparison: Sketched outline of SMS CöLN and working vessel KLEIN OTTO (U. Kunz)

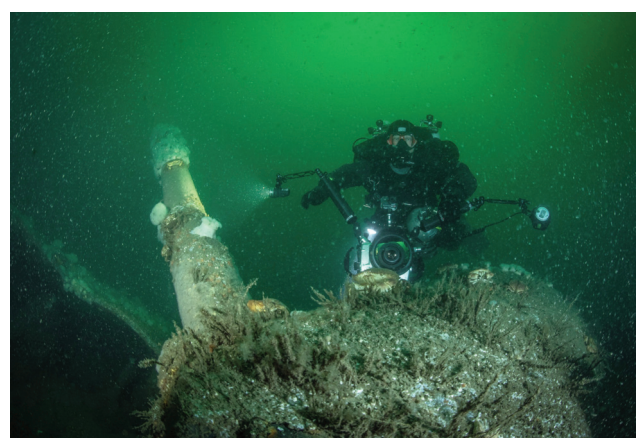
Fig. 11: Scientific Diver at one of the twelve rapid-firing-guns of SMS CöLN (10,5 cm L/45) (C. Howe)

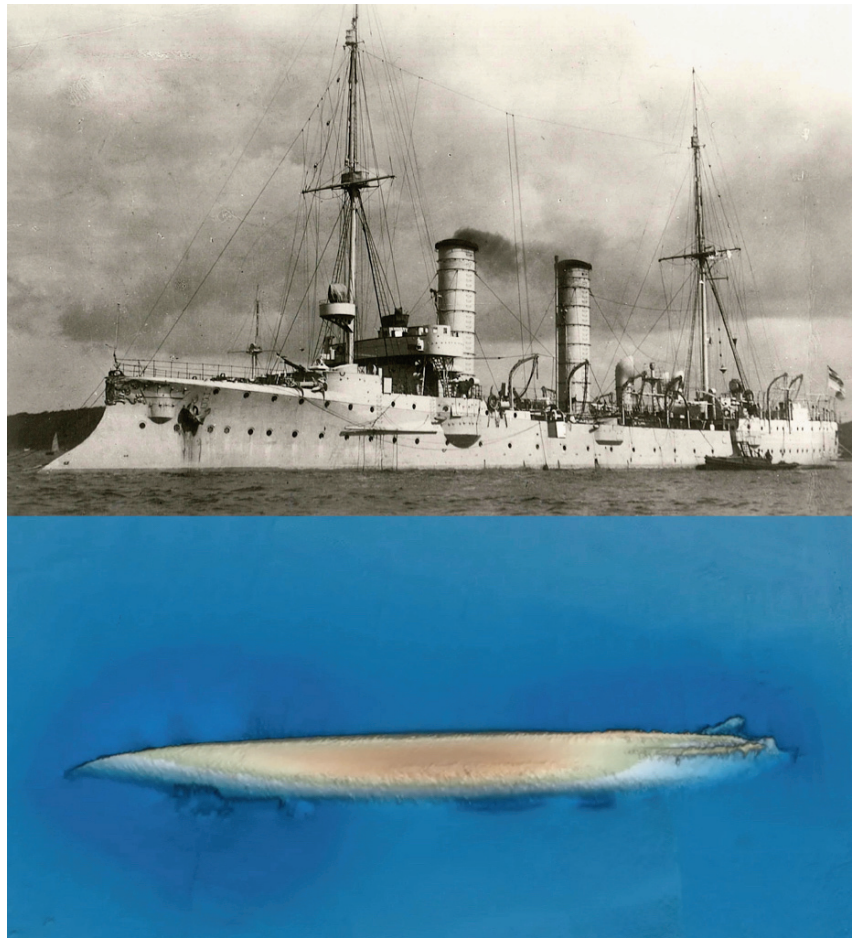
Fig. 12: SMS ARIADNE, historical photo and multibeam-image of the present-day site (Collection German Naval Association / Sea War Museum Jutland)

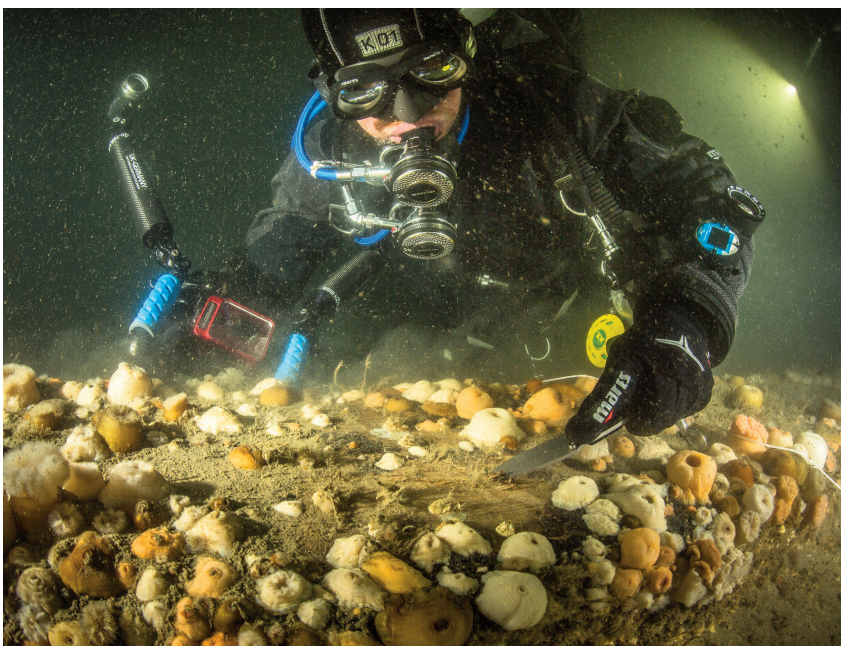
Fig. 13: A scientific diver extracts a wood sample from the false keel of SMS ARIADNE (C. Howe)

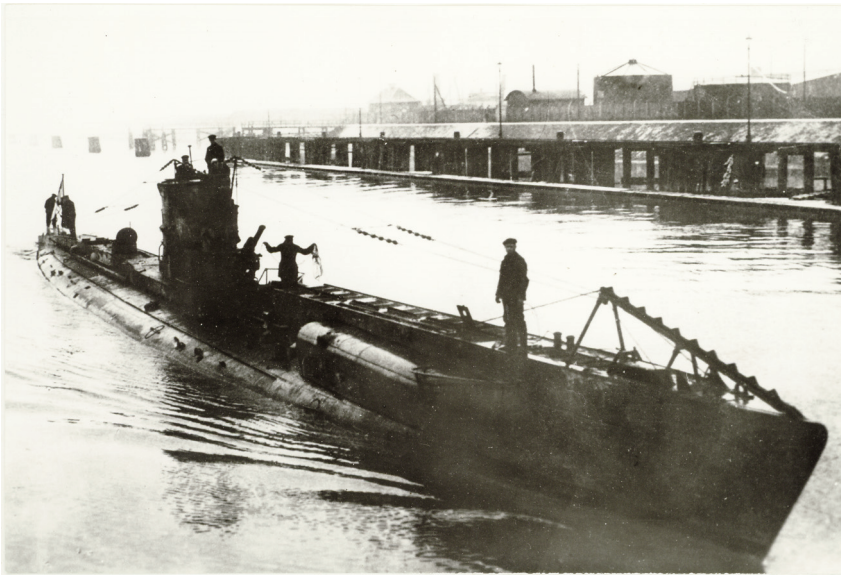
Fig. 14:
Possible photo of UC 71
(Sammlung Württembergische
Landesbibliothek / BfZ)

UC 71 was an Imperial Naval U-Boat of the UC-II type, constructed by the shipyard Blohm & Voss and launched on the 12th of August 1916. It was 53 m in length and able to reach depths of up to 50 m, generally carrying a crew of 26 (Fig. 14). One of the main advances in construction compared to its predecessor UC-I-type was the double hull. The 40-m-long, 11 mm strong cylindrical pressure hull was reinforced by a second, non-pressure-resistant hull, 3.5–4 mm strong. This created an inter-hull space, where fuel, trim and ballast tanks were placed, providing increased stability and better seagoing quali-

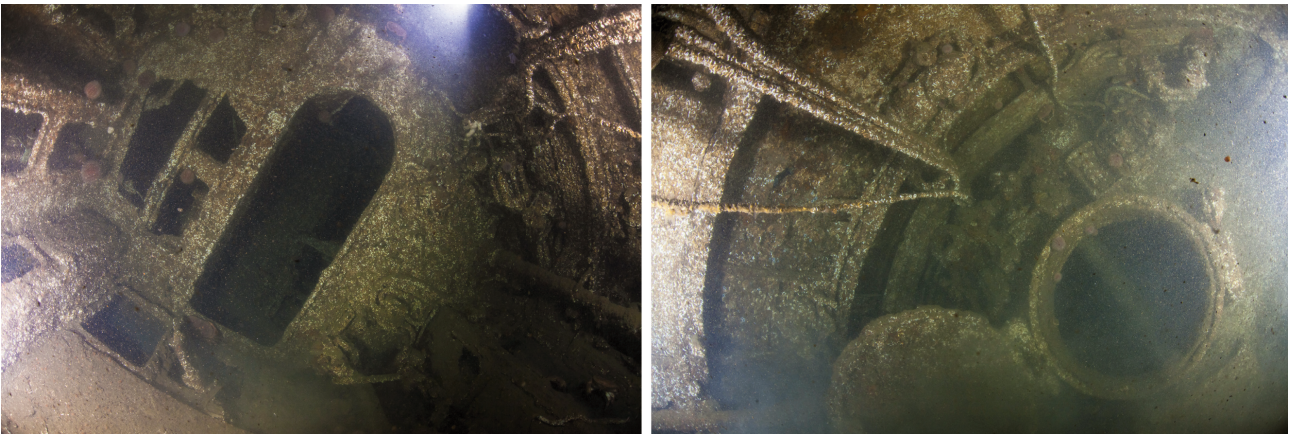
Fig. 15:
UC 71, watertight bulkheads and
portholes, all opened, within the wreck
(U. Kunz)

and bulkheads within the wreck were found open (Fig. 15). Although the telegram blames bad weather, UC 71 was probably intentionally scuttled, and the whole operation was disguised as an accident.²⁴

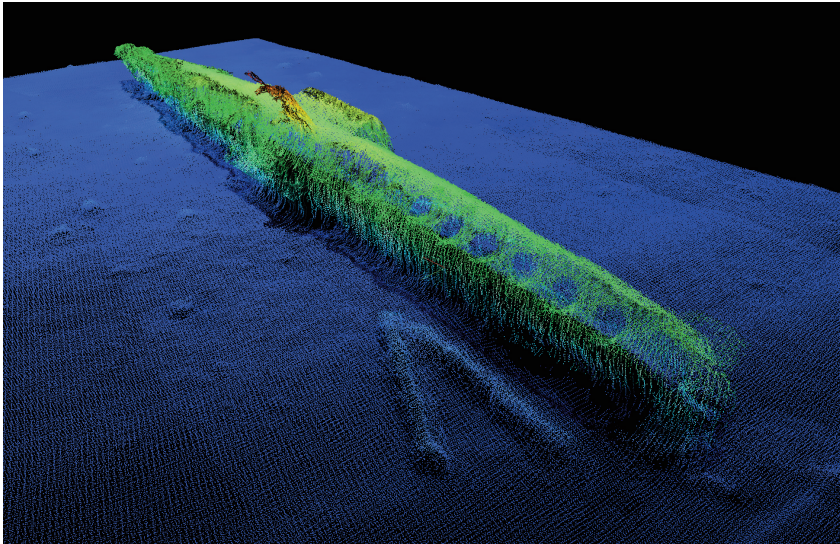
Fig. 16: UC 71, multibeam image of the two torpedoes which had fallen off. The six mine shafts are visible at the top (Sea War Museum Jutland)

The archaeological research, the resurfaced diaries, accompanied by TV documentation and other forms of publicity, finally put closure to the mysterious sinking of UC 71.²⁸ In early 2019, in cooperation with the Sea War Museum Jutland, the wreck was revisited and scanned using a high-definition multibeam, revealing two elongated tubular objects near the submarine's bow, which had not been present in 2016 (Fig. 16). Diving missions on

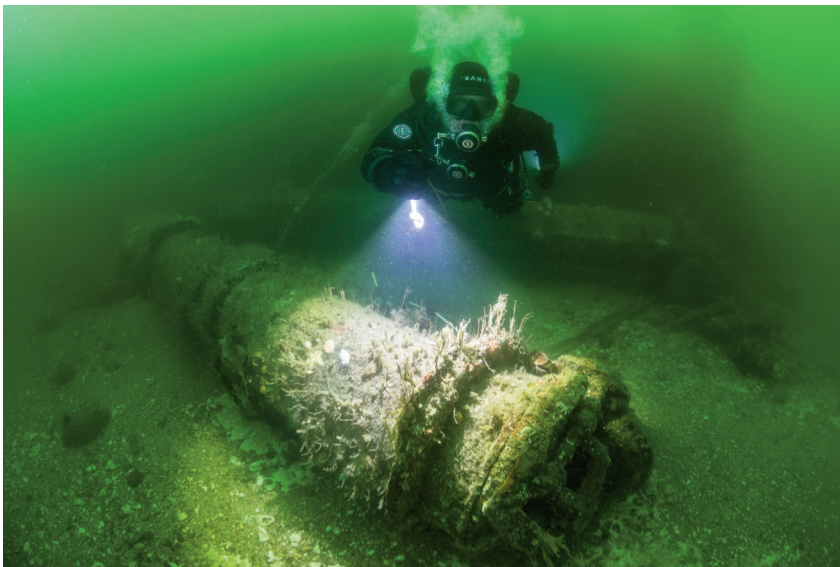
Fig. 17: UC 71, diver next to the torpedoes, which have fallen off between 2016 and 2019, a further foreboding sign that UC 71 is slowly decaying (F. Huber)

the wreck identified these as the two torpedoes, which detached from the body due to progressing corrosion (Fig. 17). Consequently, the decision was made to record the wreck using photogrammetry before decay continued. In cooperation with the 3DVisLab at the University of Dundee, Scotland, UC 71 was filmed with four cameras in 4K resolution in the summer of 2023. Around 30.000 photos were later extracted from the

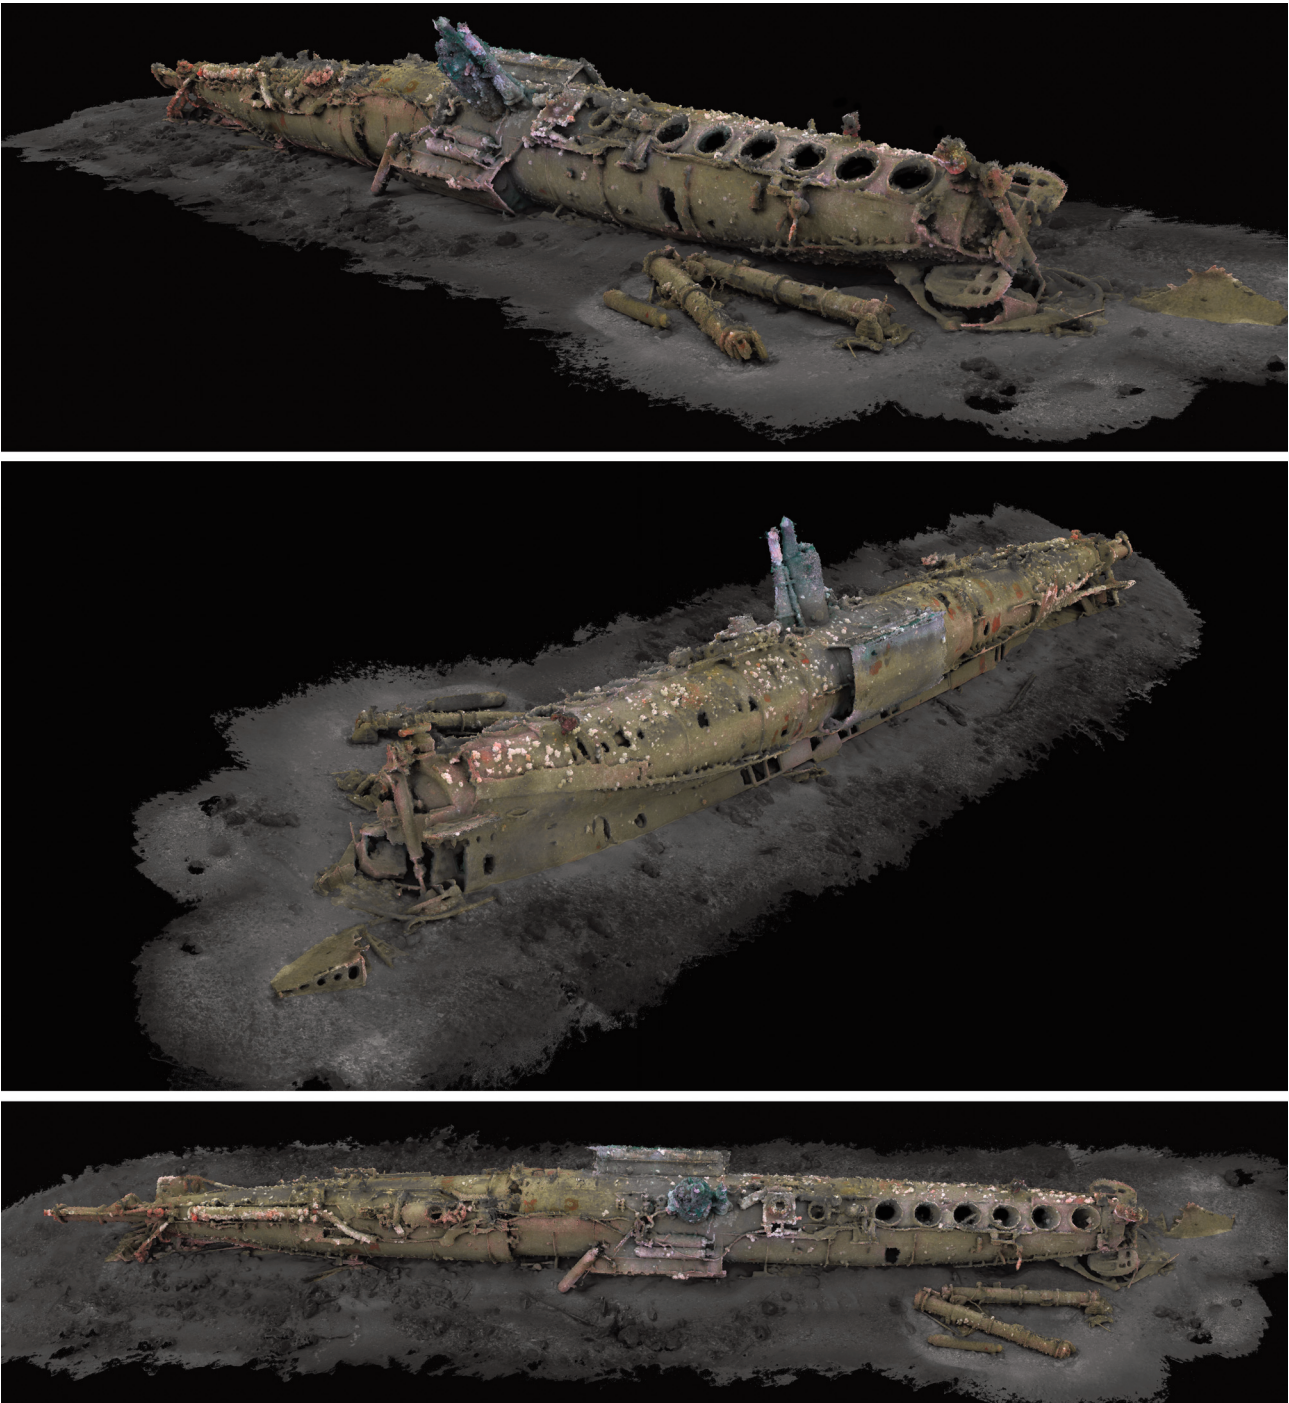
Fig. 18: Despite poor visibility and current, it was possible to document the wreck of UC 71 completely in order to create a 3D model. The printed model will be presented at the museum Helgoland from 2024 onwards (3DVisLab & Submaris)

video clips and processed into an accurate digital 3D model using the software Metashape (Fig. 18).
